Eliminating Coating Failures—A Case Study for Achieving Long-Term Cost Savings in the Oil Field

DOUG WEYBRIGHT, South Valley Corrosion Consulting, Bakersfield, California
ED DARRIMON, Bay Area Coating Consultants, Inc., Denair, California

Failure of a produced water storage tank lining within one to two years was common. Poor surface preparation was the main cause. This article shows how proper blasting, salt removal, and the use of a heat-resistant lining material will give the tanks the service life desired by the owner.

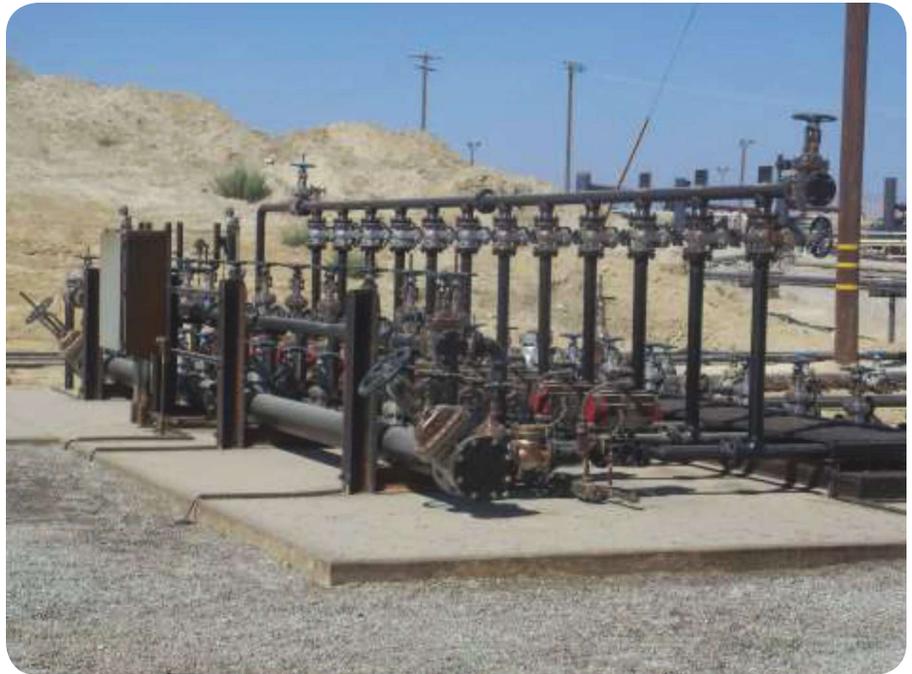
FIGURE 1 Steam injection platform.

This is the case history of one of several major oil producers in the San Joaquin Valley, whose core competency is thermally enhanced production and recovery from various oil fields in California. The company's significant asset base produces a large share of the heavy, viscous oil extracted through steam injection in one of California's most prolific producing areas. Oil fields with low-gravity crude oil are steam flooded (Figure 1) with softened

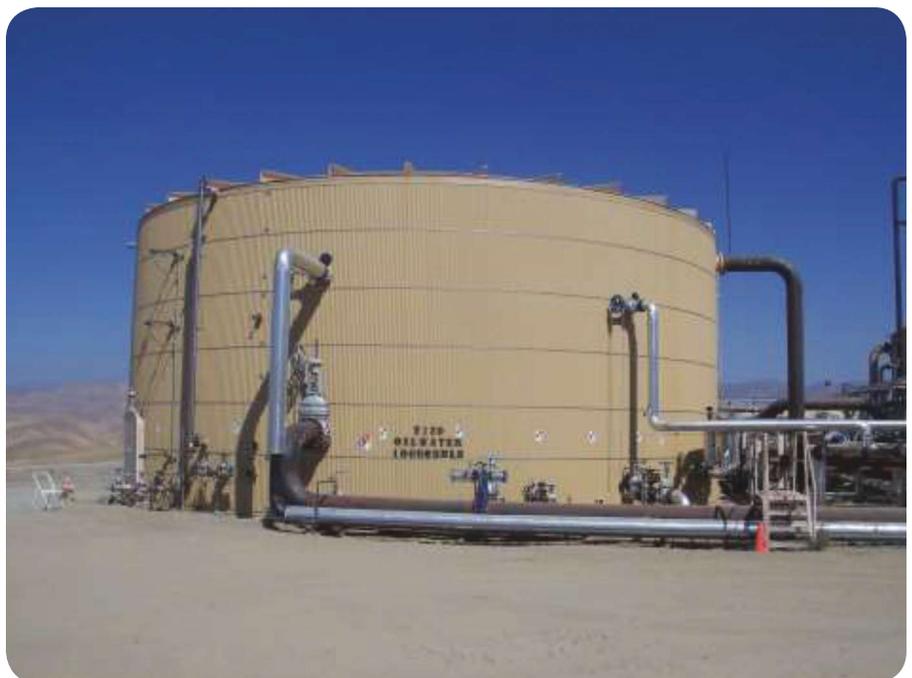
FIGURE 2 A 10,000-bbl produced water tank.

The crude oil and water mixture returning to ground level at temperatures of ~160 °F (71 °C) goes through a separation process. The water is typically accumulated in 5,000- to 10,000-bbl (795,000- to 1.59 million-L) produced water tanks (Figure 2). These steel tanks store valuable recovered water and are found all over the producing areas of the San Joaquin Valley, which until recently represented almost 10% of all crude oil produced in the United States.

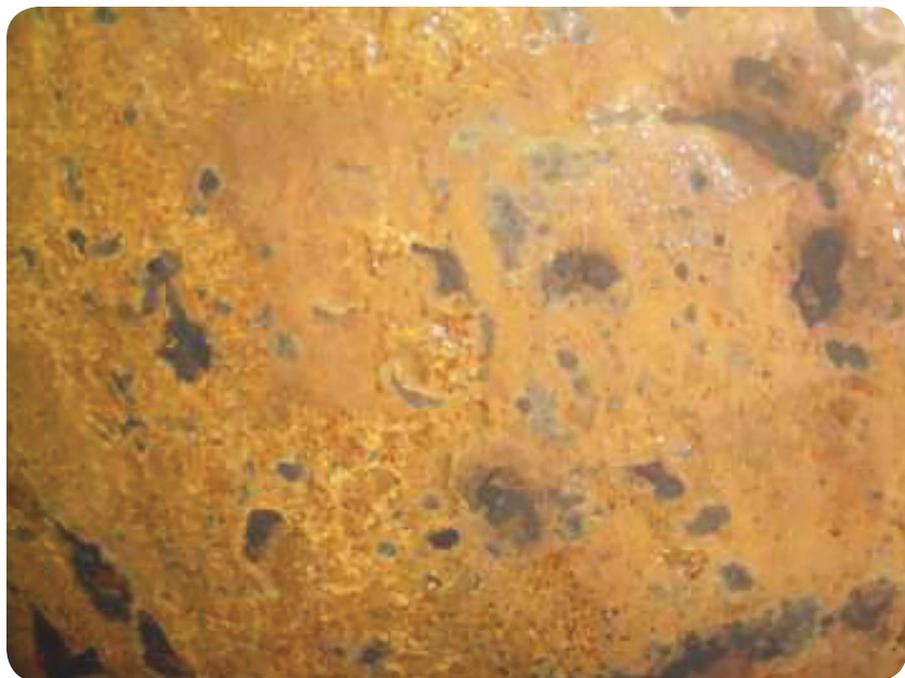
Prior to 2003, the company's surface preparation specifications for produced water tank lining projects required only a white metal blast, repair of pits, surface testing by conductivity for residual contaminants, and coating with a thermally tolerant lining. The surface area for preparation involved the entire tank interior, including the roof, or ~7,500 to 9,500 ft² (697 to 947 m²). The common experience was that the coating system would fail in less than two years, with many documented cases of coating failure in less than a year. Various thin-film coatings had been used and it was originally thought that the coating systems were unable to tolerate the rising operating temperatures, which increased incrementally through the years as thermal injection became more efficient. More robust thin-film, solvent-based, and thermally resistant coatings were applied, yet failures continued unchecked. Forensic analyses of failed coatings indicated 12 to 16 mils of dry film thickness; however, it was not the coating that was intolerant to the service but rather inadequate surface preparation that led to osmotic blistering and spot coating failures (Figure 3). Modification of surface preparation

FIGURE 3 Corrosion on the inside of the produced water tank.

methods by incorporating the use of ultra-high water pressure blasting did not resolve the problem.

The company worked closely with Bay Area Coating Consultants (Modesto, California), an industry-recognized third-party consulting and inspection firm, to change its specification, and tendered it for contractor bidding in August 2003. The initial changes included testing for chloride, sulfate, and nitrate ions immediately after white metal abrasive blasting or ultrahigh pressure (UHP) washing. Special attention was given to testing around weld seams and where metal loss or pitting was apparent. These were the locations where forensic analysis of coating failures showed the largest number of osmotic blistering and coating degradation. Other changes instituted were post-cleaning, use of 100% solids material, more aggressive anchor profile and blast cleanliness, use of climate control equipment, and prequalification of application contractors.

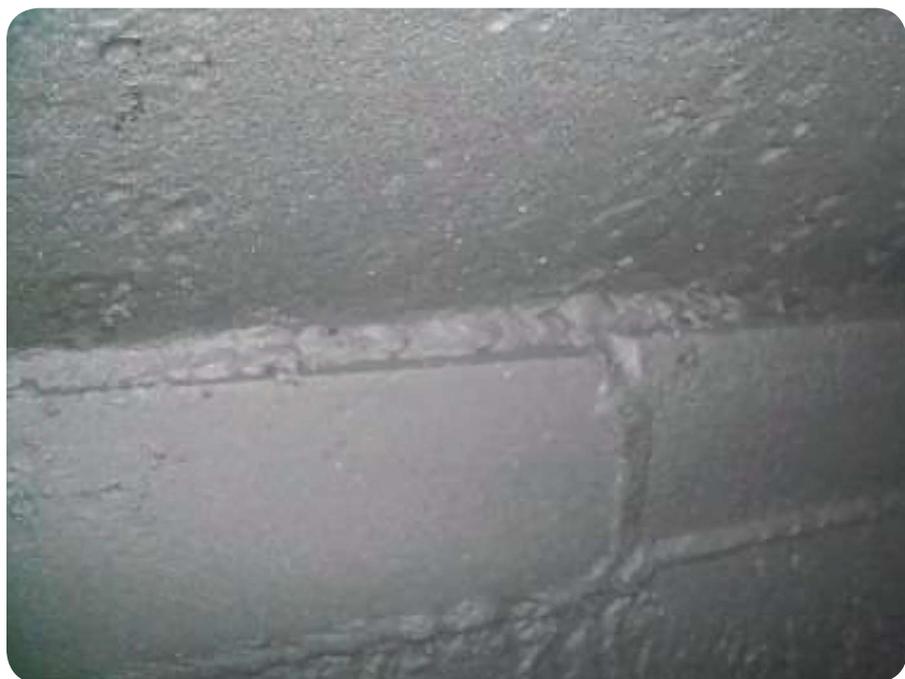
FIGURE 4 White metal blast, as defined in NACE No. 1/SSPC-SP 5.

New tanks do not require UHP and pressure can be reduced to 5,000 psi (34 MPa). Surfaces are then abrasive blasted to NACE No. 1/SSPC-SP 5² (white metal) (Figure 4) and followed by surface testing to ensure the salt limits have been met. The test kit is specified for testing surface chloride, nitrate, and sulfate ions. The limits are non-detectable levels of chloride, 5 µg/cm² for nitrate, and 5 µg/cm² for sulfate. The anchor profile required is 2 to 4 mils (51 to 102 µm) (Figure 5).

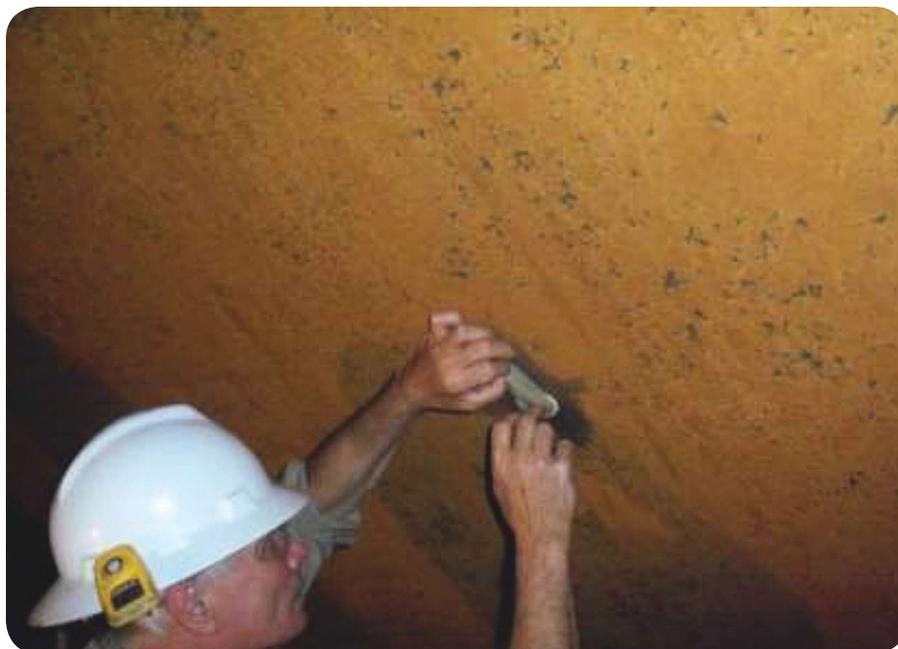
FIGURE 5 Surface testing.

A rigorous review of comparative project costs to determine the impact of the specification changes to ion-specific testing and incorporation of salt decontamination determined there is no added incremental cost. The ion-specific testing and test kit provide one decontamination step (Figure 5) to replace inadequate conductivity surface testing and multiple high-pressure washes with an undetermined outcome.
