# Field Performance Comparison

## HOLD\*BLAST vs. HoldTight 102

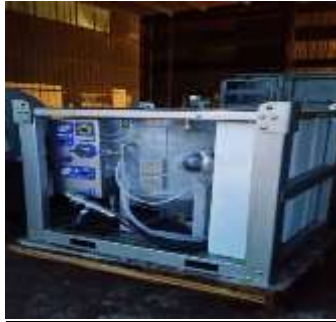
### Equipment

- Location: Sturgeon, Bakersfield, CA
- Same A-36 carbon steel for similar fabricated steel parts and equipment.
- Blast equipment: Graco EQ600 mist blaster.
- Blast media: Red Garnet, 80 grit.
- 1:50 dilution. Dilution rate as stated in the respective directions.
- Dilution with (Culligan) deionized water.
- 2 to 2.5 mil profile.
- Same blasting contractor and operators.
- Ambient conditions: Ave. temp.: 63°F; ave. humidity: 42%; ave. dew point: 35°F

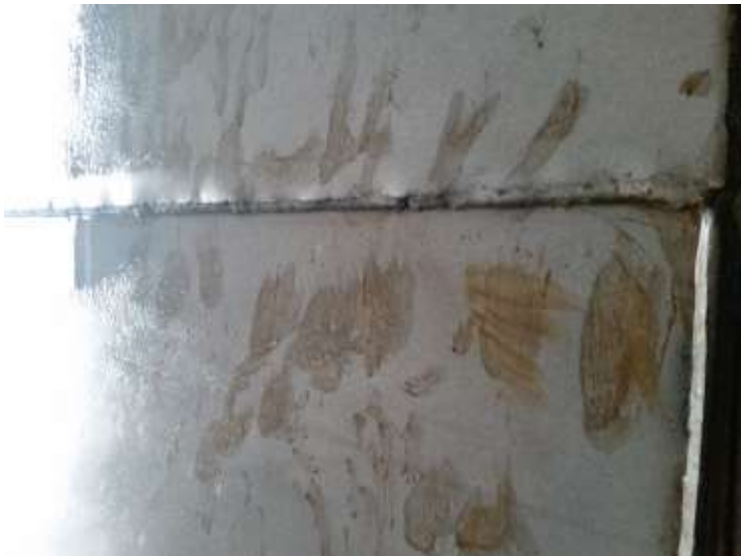
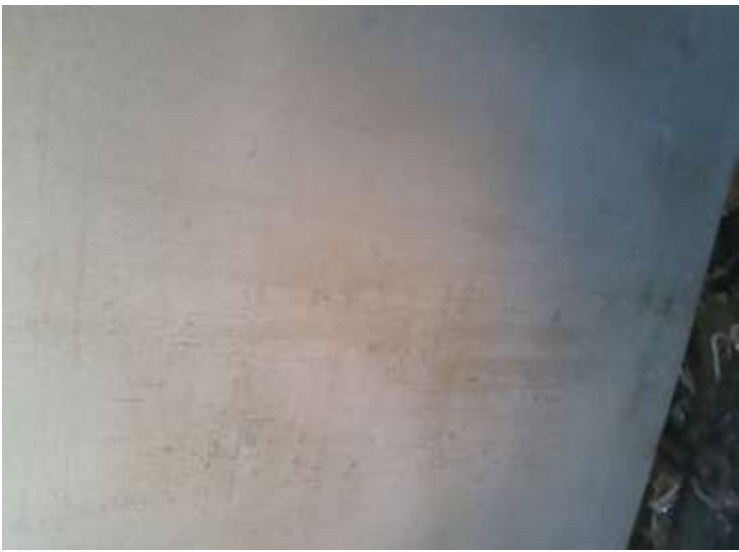
March 30 through April 1, 2015: fabricated vapor box trailer was abrasive blasted. By March 31<sup>st</sup> blasted areas with HoldTight 102 began to flash rust:

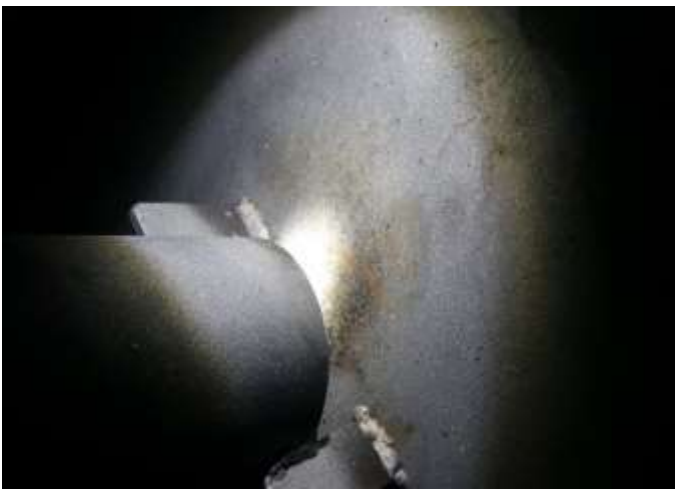
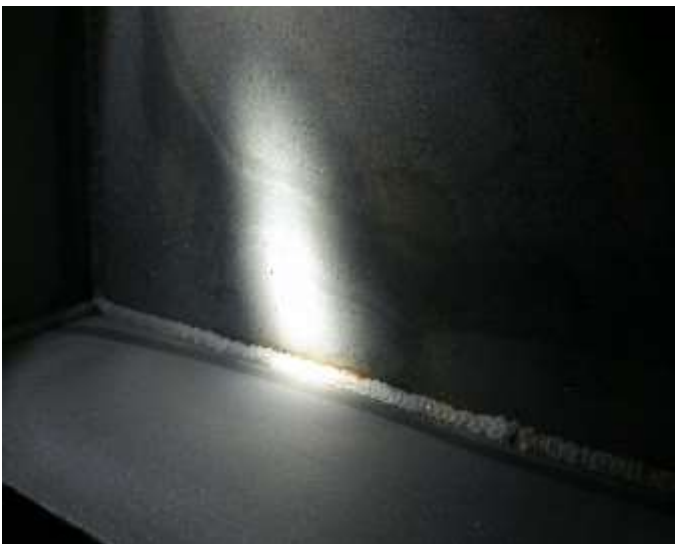
Areas that flash rusted were reblasted on April 1<sup>st</sup>. 12 hours later reblasted areas had failed again:

On April 2<sup>nd</sup>, those areas that turned after 2 vapor blastings with HoldTight102 were sanded with 80 grit paper to remove the flash rust. Hand repaired surfaces of the vapor trailer were then coated on April 3<sup>th</sup>.

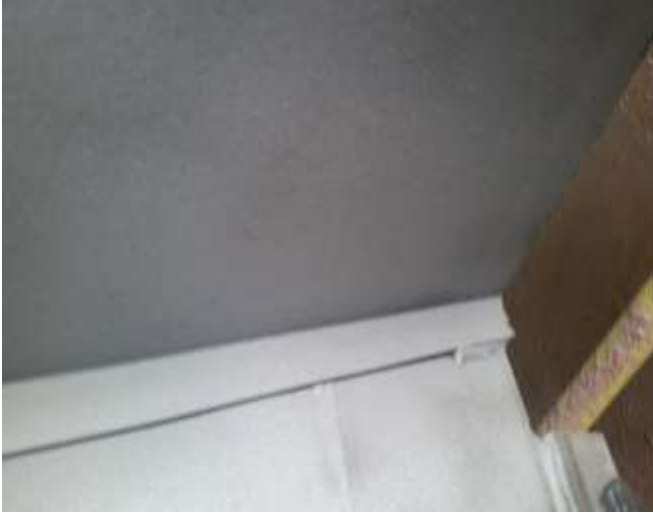
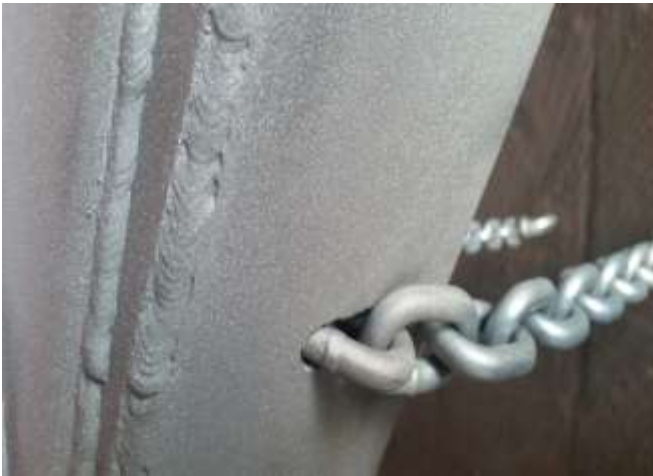
On April 8<sup>th</sup>, 3 eye wash trailers were abrasive blasted with HOLD\*BLAST. On April 10<sup>th</sup>, after 36 hours:

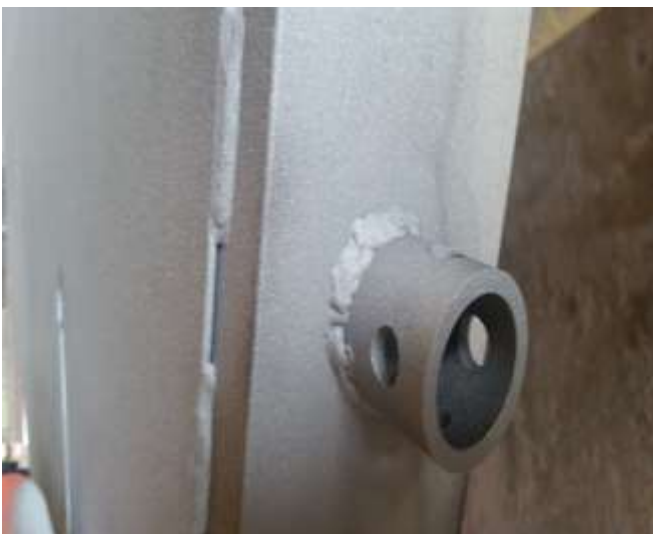
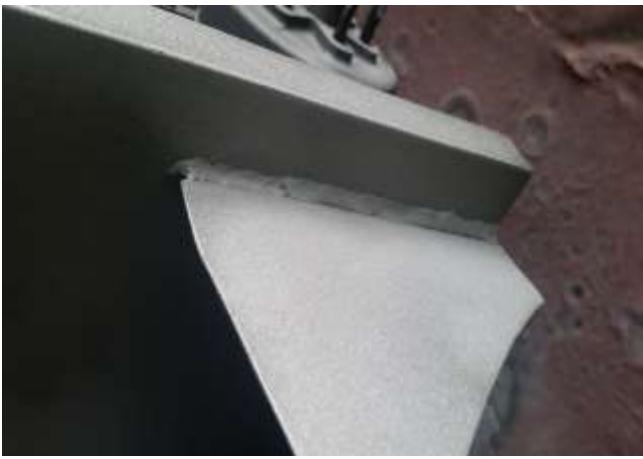
55 hours after mist blasting with HOLD\*BLAST:

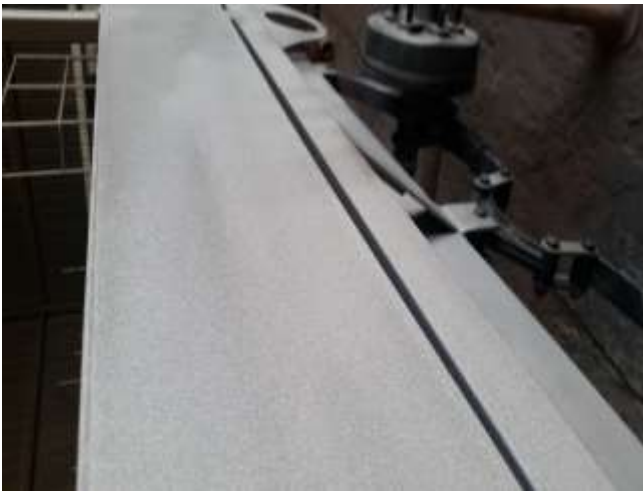
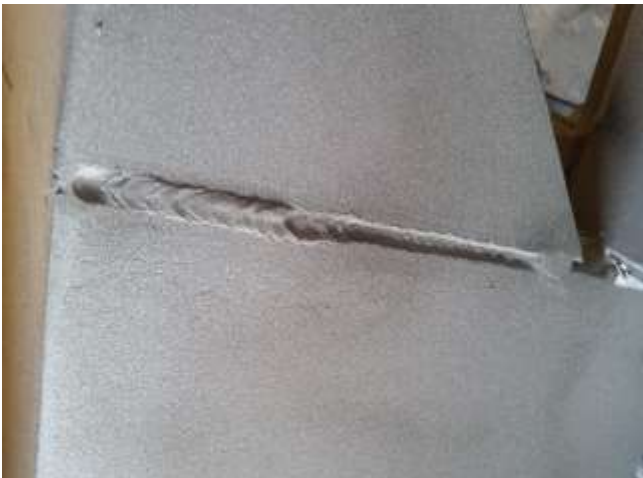
120 hours after mist blasting with HOLD\*BLAST:

On April 13<sup>th</sup>, surfaces blasted with HOLD\*BLAST were coated.
